Manhole Inspection Summary

Manhole # S17AA2005MH

Insp Date: **11/13/06 2:03 PM**

Location Address: **1815 GREENBERRY RD**

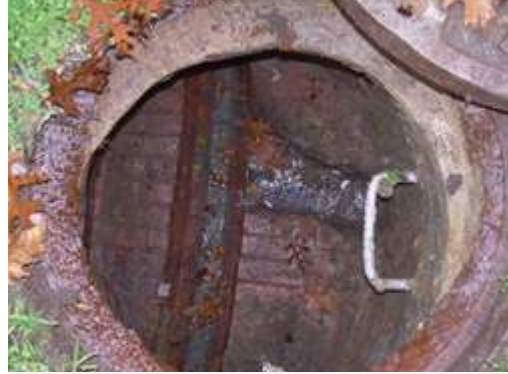
Top View

Evidence of surcharge - Bench debris.
Channel debris.

Parged wall I3 side.

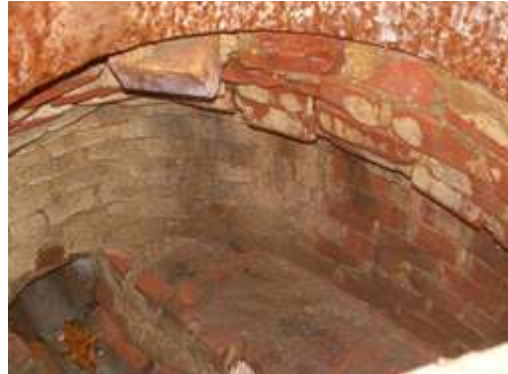
Defect

Condition: ☐ Sound ☐ Cracked ☐ Root Intrusion ☒ **Loose Brick** ☒ **Deteriorated**

Infiltration: ☐ None ☒ **Joint** ☐ Cracks ☒ **Mortar** ☐ Roots ☐ Wall

Adjustment deterioration, loose brick and
infiltration. Barrel infiltration.

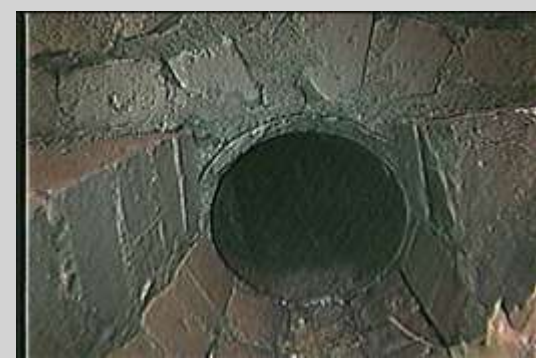
8 in. Circular Gravity Sewer Pipe Out @ 12 O'Clock

Channel deterioration.

Infiltration: **Evidence** Pipe Seal Cond: **Cracked**

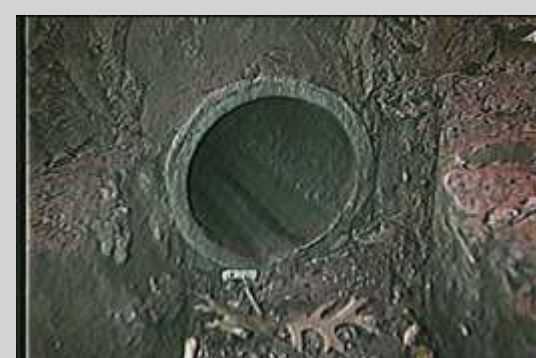
6 in. Circular Gravity Sewer Pipe In @ 3 O'Clock

Deposits: ☐ None ☒ **Mud** ☐ Sludge ☐ Debris ☒ **Grease**

Infiltration: **Evidence** Pipe Seal Cond: **Unknown**

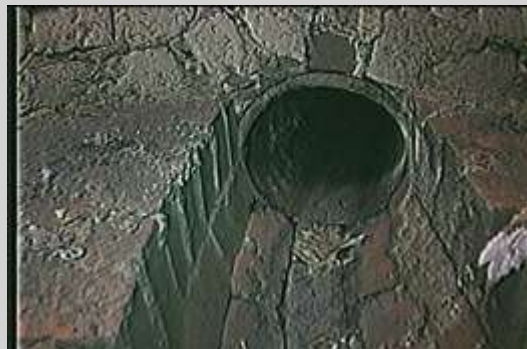
Pipe In @ 6 O'Clock

Barrel deterioration and infiltration. Channel deterioration.

Pipe Seal Cond: **Cracked**
